Plymouth's Elizabethan House

The Elizabethan House

A survival from the late 1500s when Plymouth was a thriving port, the Elizabethan House has endured early 1900s slum clearance and the Blitz. Vital structural and strengthening works were carried out as part of Plymouth's Mayflower 400 commemorations. Project architect and SPAB Scholar Izaak Hudson explains the SPAB's unique involvement in the building and some of the challenges of the project.

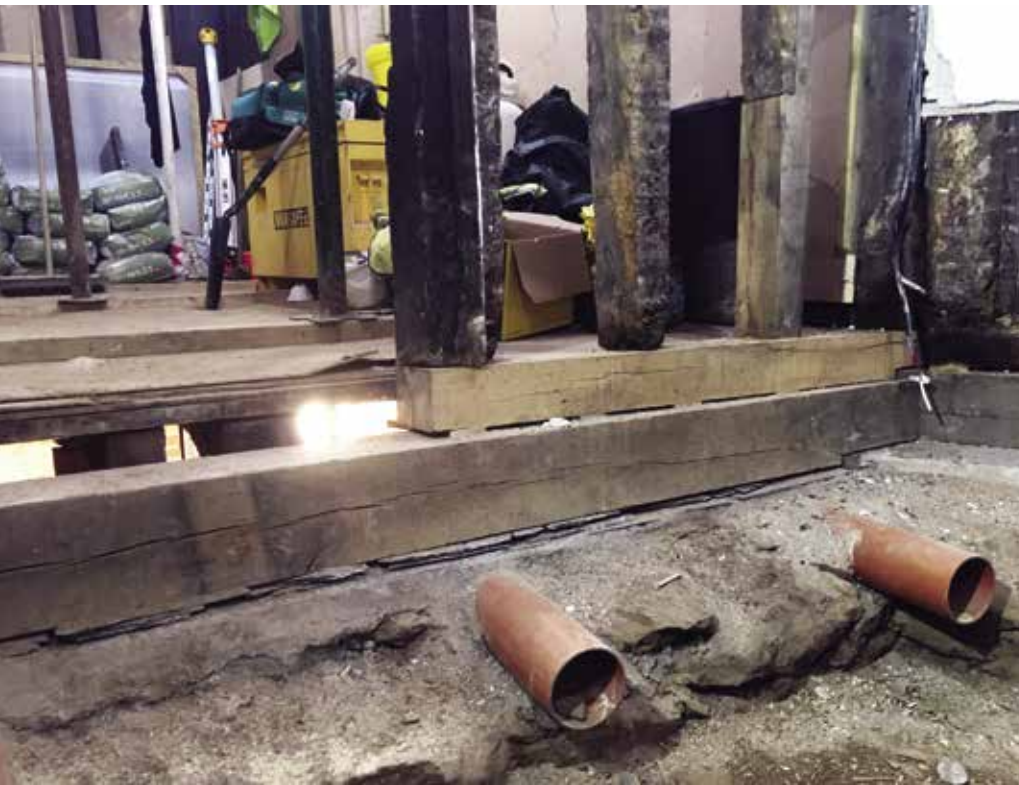
Above Oak sole plate repairs and ducts for radon protection on site

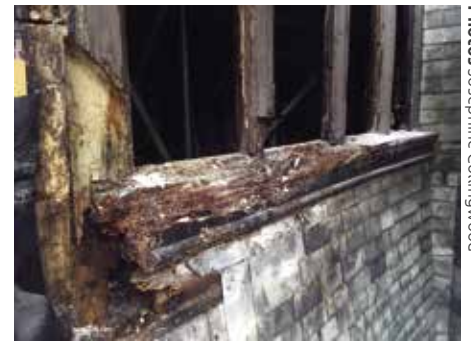
Top Rotten window cill and frame members uncovered for repair

The project did throw up some challenges on site; more timber decay than anticipated was uncovered behind walls that just couldn't all be opened-up beforehand. After Covid restrictions were applied in the Spring of 2020 there was a limit to the number of workers than could be in the same areas together, which inevitably slowed-up work in such confined rooms. Dampness levels in the west wall initially fell but then unexpectedly rose as the project neared completion, complicated by the internal earth plaster which as well as being intentionally 'breathable' also starting to act as a poultice and draw

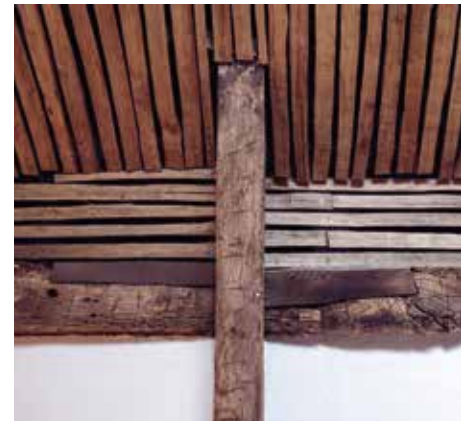
Above Pieced-in oak wall plate and chestnut ceiling laths

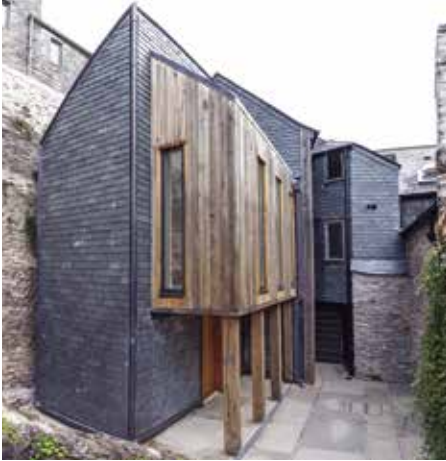
Above The new oak and Delabole slate rear extension

A proposal was developed for a two-storey extension to act as a buttress to the house and rear range oak roof trusses which were racking outwards. The extension would also house the new toilet, a meeting room and kitchen for museum staff, and plant and server rooms to service the new museum fit-out and particularly the intensive audio-visual installation. By housing all these services in the new slate and oak extension, the existing historic rooms all retain their original configuration.

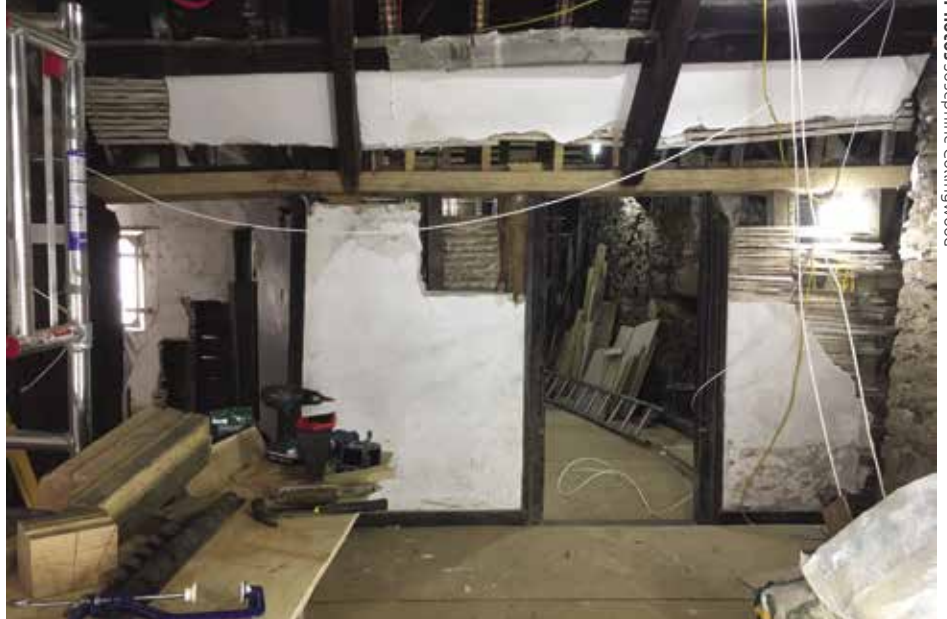
Right Repairs to the leaning spine wall

At the Elizabethan House, the lean of the central spine wall between the ranges caused by roof spread had reached a point where it would continue to lead out under its own weight without structural intervention. Of more serious consequence was the continual movement of the truncated rear range, and extensive water ingress though the slender rear wall (originally an internal partition). The rooms were quickly

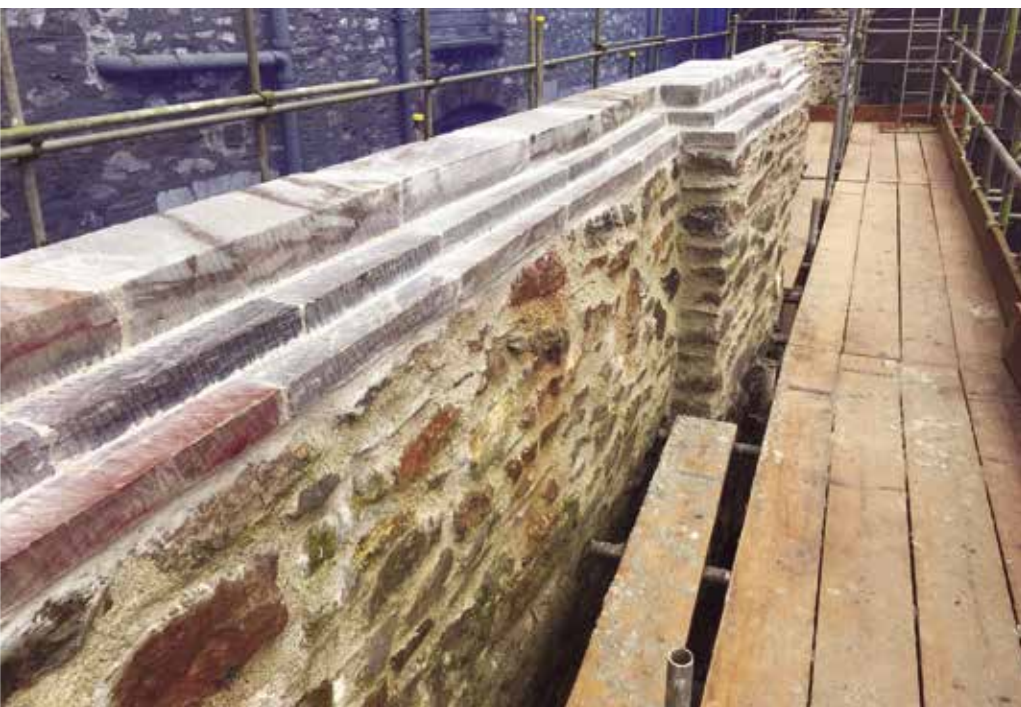
Left Repointing and new capping of the garden walls in Plymouth limestone

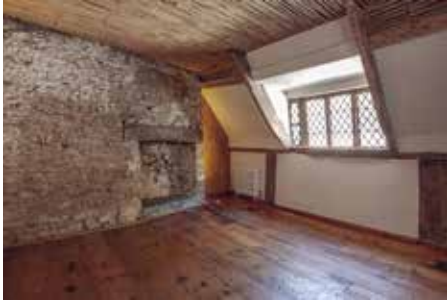
Above The top floor room following repairs

The exhibition designers asked for the main room on the top floor to be left in a partially completed state to reflect the exhibition design for the room detailing the building's construction. Again, this required some behind-the-scenes thought, such as installing black-painted boarding behind the laths to maintain separation through the ceiling. Although I was initially skeptical of leaving the ceiling unplastered, the variety of materials and light across them now makes this one of my favourite rooms in the building.
